Manhole Inspection Summary

Manhole # S25WW_009MH

Insp Date: **7/14/08 10:08 AM**

Location Address: **3201 CLIPPER MILL RD**

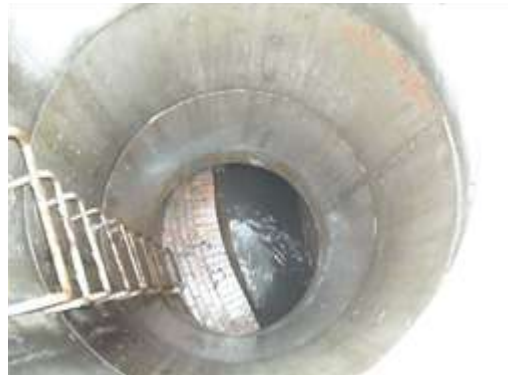
Top View

Bench debris.

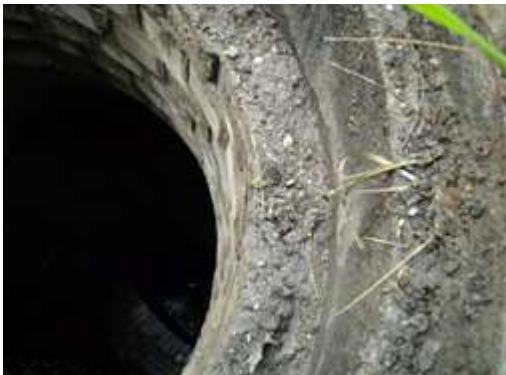
Defect

Offset: **2.5** (in.)

☒ **Leaks**

Condition: ☐ Sound ☐ Cracked ☐ Root Intrusion ☐ Loose Brick ☒ **Deteriorated**

Frame leaks. Frame offset. Adjustment deterioration and infiltration.

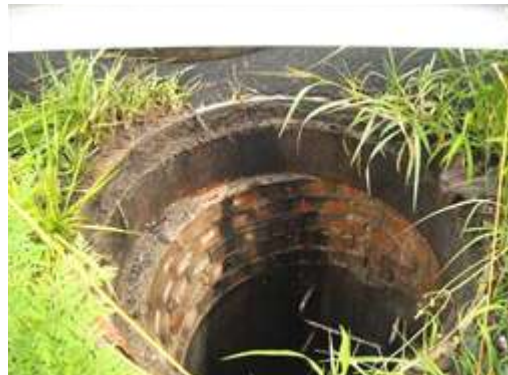
Defect

Subject To Ponding: **Sheeting**

inflow evidence from sheeting

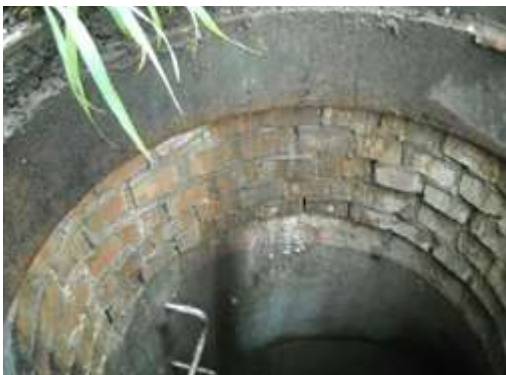
Defect

Infiltration: ☐ None ☒ **Joint** ☐ Cracks ☐ Mortar ☐ Roots ☐ Wall

Infiltration: ☐ None ☒ **Joint** ☐ Cracks ☐ Mortar ☐ Roots ☒ **Wall**

Frame leaks. Adjustment deterioration and infiltration. Cotrbel and Barrel infiltration.

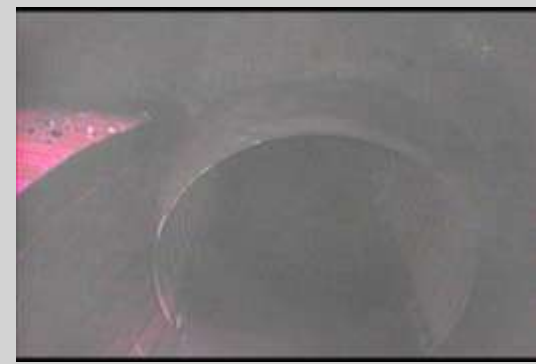
36 in. Circular Gravity Sewer Pipe Out @ 12 O'Clock

Pipe Material: **Unknown** ☒ Pipe Lined

Infiltration: **None** Pipe Seal Cond: **Unknown**

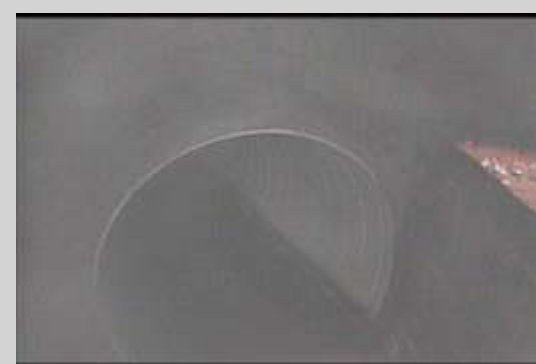
36 in. Circular Gravity Sewer Pipe In @ 5 O'Clock

Pipe Material: **Unknown** ☒ Pipe Lined

Infiltration: **None** Pipe Seal Cond: **Unknown**
